MedSun Newsletter #50, July 2010

Articles

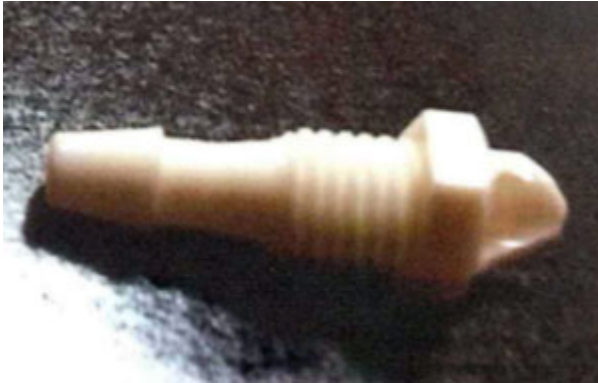
Teenage patient status post (S/P) respiratory arrest with history of Downs syndrome and self injurious behaviors intubated on admission to the pediatric intensive care unit (PICU). Patient with significant pulmonary edema, reactive airway and subcutaneous emphysema. Patient placed on 3100B Carefusion SensorMedics oscillating ventilator which malfunctioned. Patient was ambu bagged for 75 minutes while troubleshooting by respiratory. Patient required Dopamine for hypotension. Upon inspection of circuit, noted to have broken luer fitting which provides connection to the end of the circuit for measuring mean airway pressure had broken (white airway pressure port). This is the second occurrence of this type.

Broken luer port.

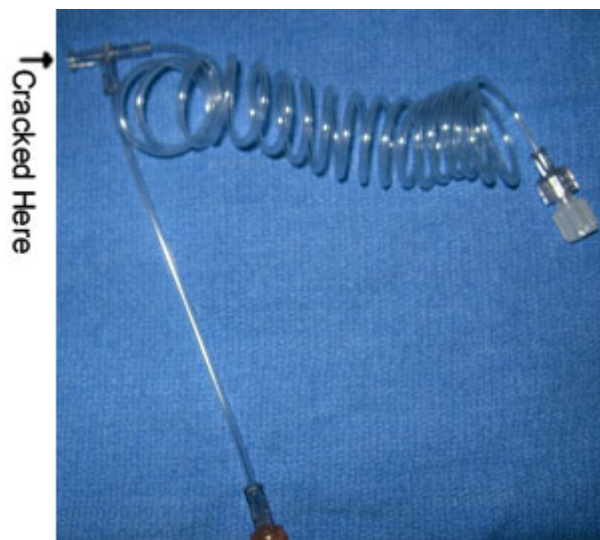
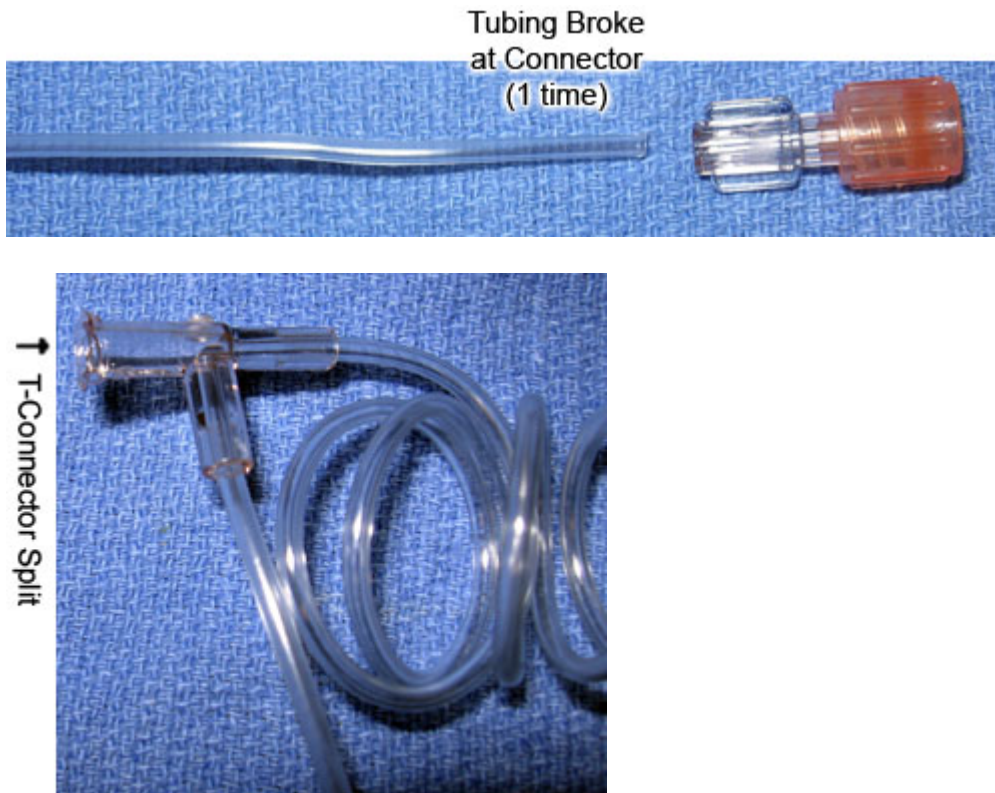
Multiple problems with tubing not adhering to connectors and T-connectors cracking. For example, in one case the connector will separate from the tubing. In another case the connector hub is cracking when used. This has happened multiple times recently, but 4 times within 24 hours where the product has been saved. We have retained 6 defective sets from two lot numbers. MedRad says they are aware of the problem and will provide replacement tubing. MedRad declined to tell me what lot numbers were affected.

Defective product.

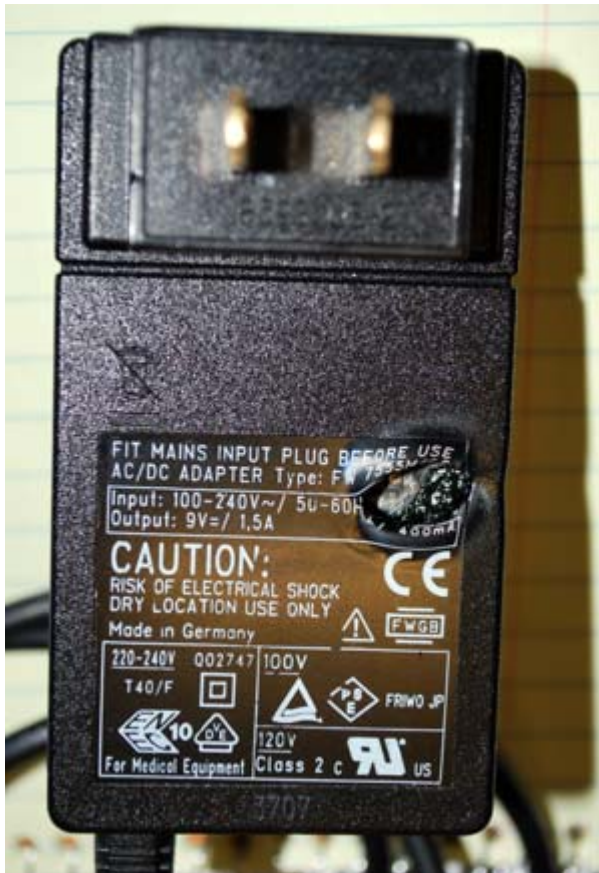
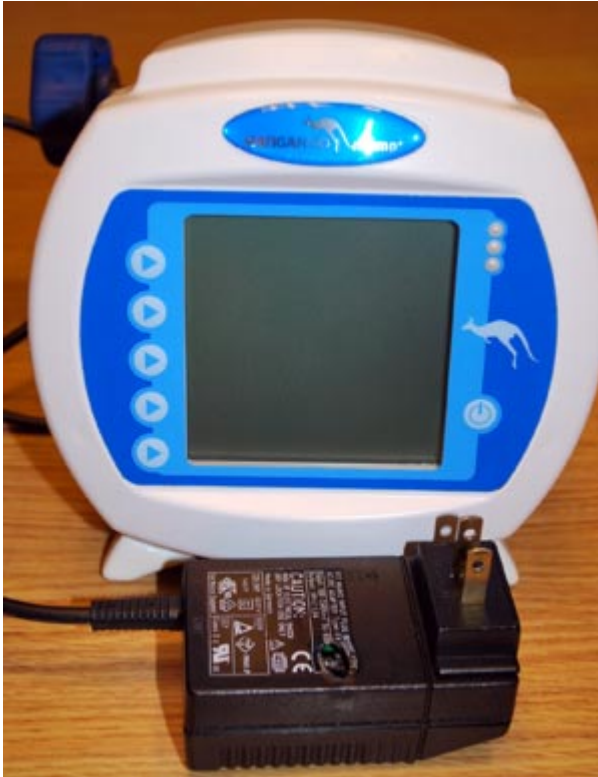
Power cord plug containing electronics and transformer failed and burnt a hole in the case of the power plug. Fire department called and responded and patient was evacuated from their room.

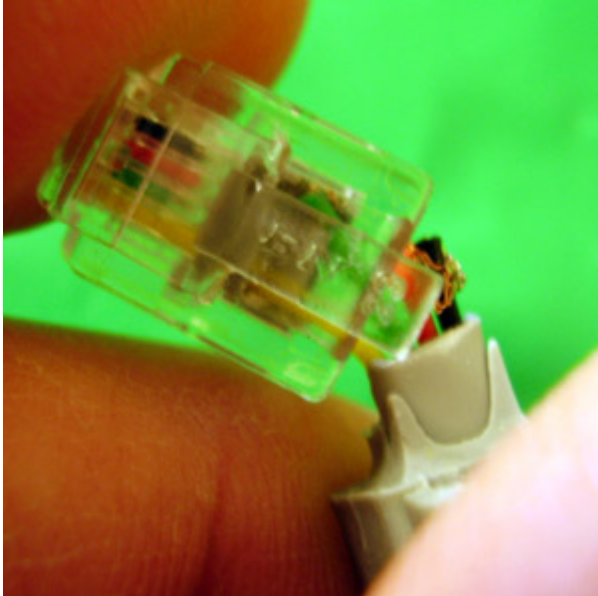
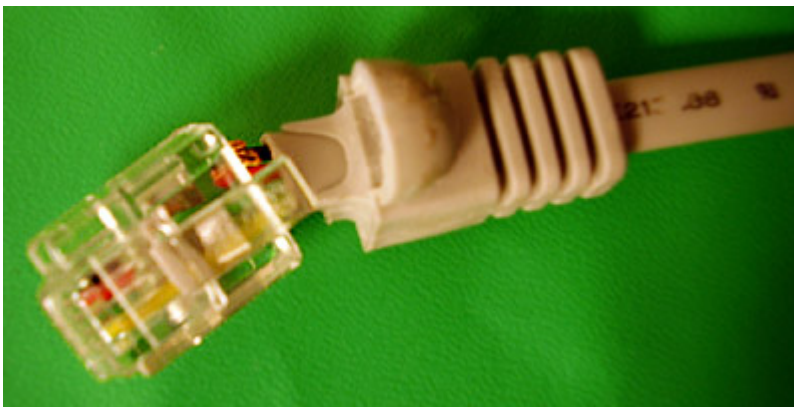
Patient in bed placed on top of Keep Safe Posey brand bed-alarm pad. Posey bed alarm sounded frequently during the night. Nurse entered room and reset alarm each time, checked connections, and bed pad placement. Morning care provided and nurse left room. Immediately notified that patient was on the floor. Bed alarm did not sound. The batteries were verified as having been in proper range although I can state without hesitation that they did not contribute to this failure in any manner. This device failed because the wires that are connected to the pad were so frayed that they were hanging on by a thread. The pads are connected to the monitor via RJ-11 connectors and four associated wires (the same as you would see on a standard telephone cord). Each wire has ~8-10 twisted strands. When we received the pad in Clinical Engineering it was evident that the strands were completely severed on one of the 4 wires. The other three wires were in very poor condition – having been pulled out of the RJ-11 connector so you could see the exposed color wire sheathing of the remaining three wires. These cords are the least durable component in this system and highly vulnerable to failing – which is quite

The device failed to alarm when the patient attempted to get out of bed.
